**AFRL-VA-WP-TR-2003-3088**

**INVESTIGATION OF THE EFFECT OF  
CORROSION PITTING ON FATIGUE  
LIFE OF ALUMINUM STRUCTURE**

**OCTOBER 2003**

**Final Report for 01 July 2001 – 31 December 2002**

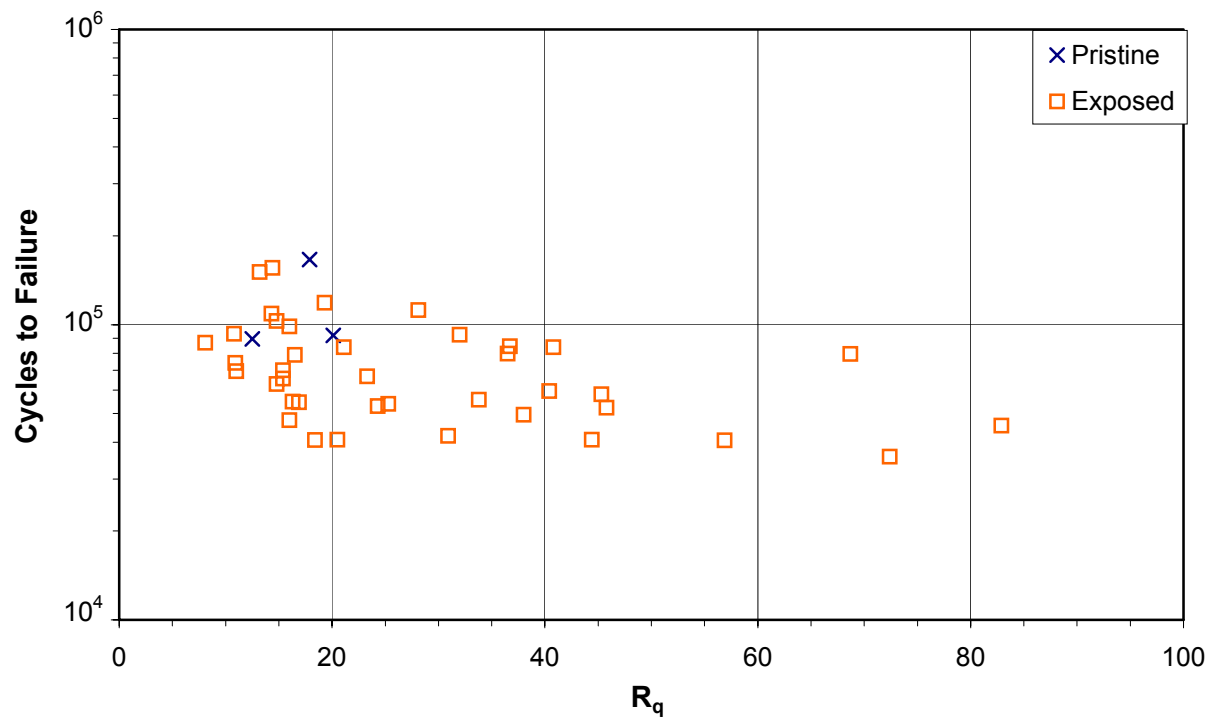
Figure 5. Fatigue Life versus Root Mean Square Roughness,  $R_q$ .

Correlations of the root-mean-square roughness,  $R_q$ , and the maximum valley,  $R_v$ , with fatigue life are shown in Figures 5 and 6. General trends are observed in both figures but considerably more data is required before we can determine if either of these quantities is a good indicator of the reduction in fatigue life. Since  $R_a$  tracks  $R_q$  closely and  $R_q$  seems to be more sensitive to variations in surface texture, only  $R_q$  needs to be looked at. Similarly,  $R_v$  represents the deepest hole into the specimen that concentrates stress around it, whereas the maximum peak,  $R_p$ , represents a protrusion that is lightly loaded. So we would expect fatigue life to correlate more with  $R_v$  than with  $R_p$ .

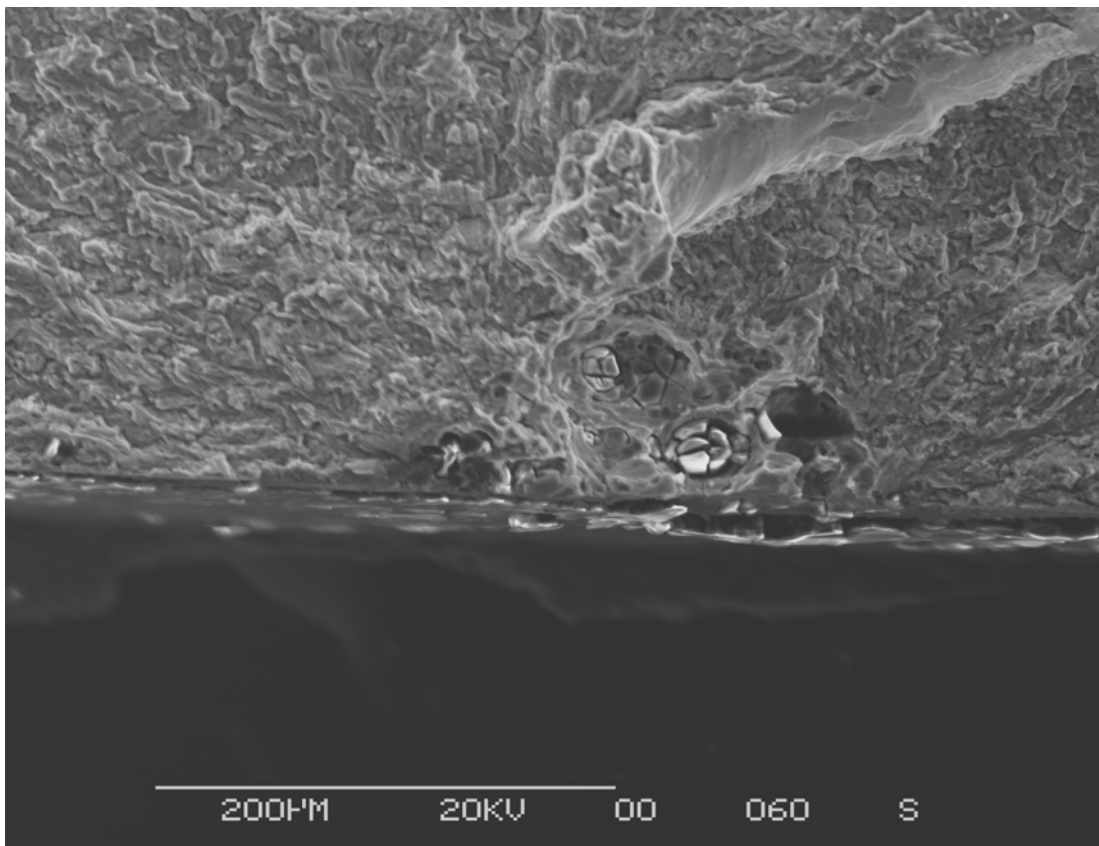
**Figure B-4. Crack Origin A (Fig. B-3) on Specimen 1331.**

Origins are at A and corner at lower left. Feature B may be origin or just large pit.

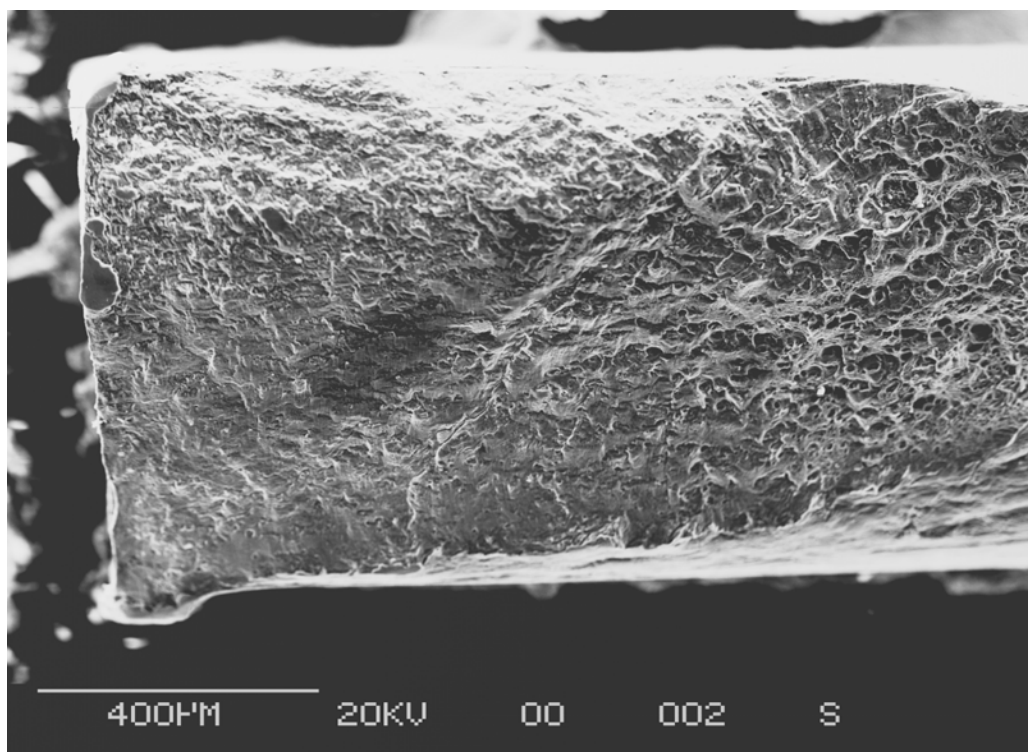
**Figure B-8. Fatigue Crack on Fracture Surface of Specimen 5608.**

Origin is at corner in upper left of photograph.

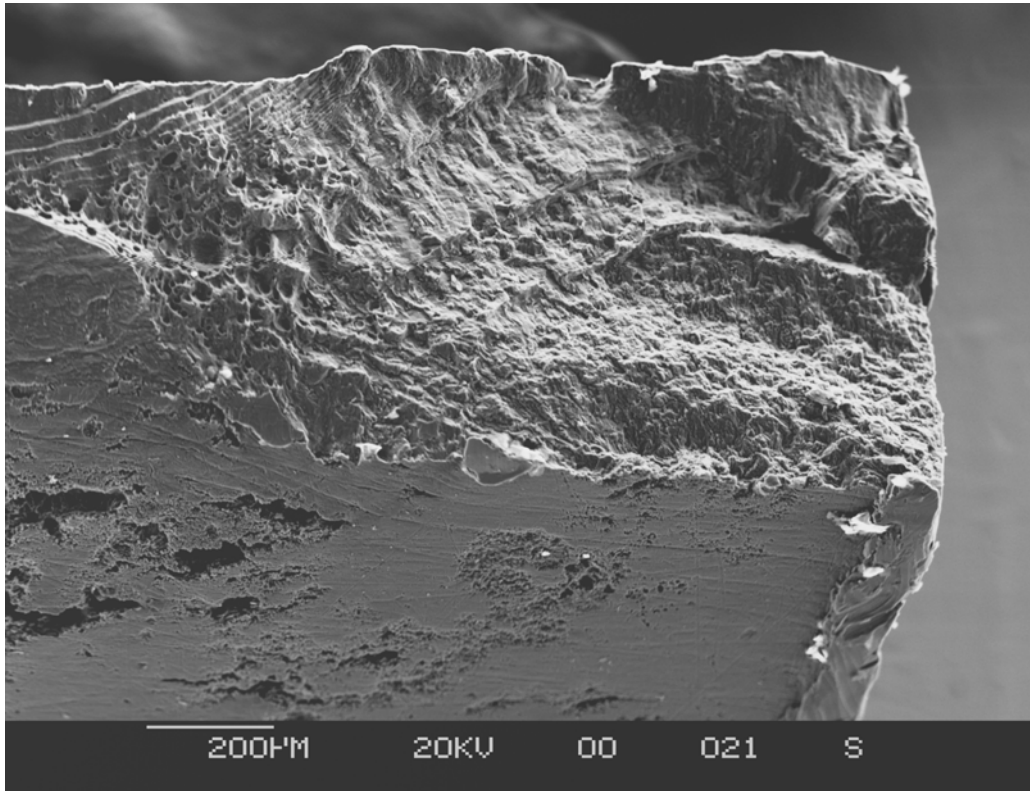
**Figure B-9. Fatigue Crack on Fracture Surface of Specimen 5616.**

One origin is at a pit, but the dominant crack seems to have come from the corner at lower right.

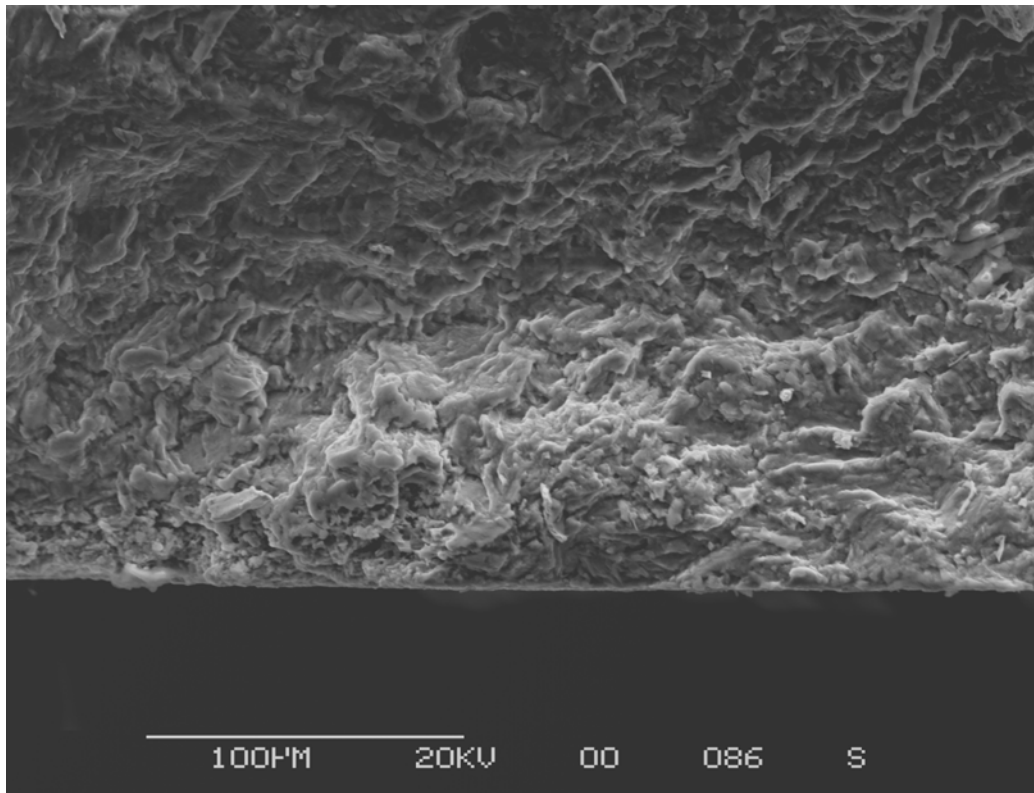
**Figure B-13. Origin A (Fig. B-12) on Specimen 5618.**

Two origins are along the lower edge of specimen. Dominate crack seems to have come from corner at lower left.

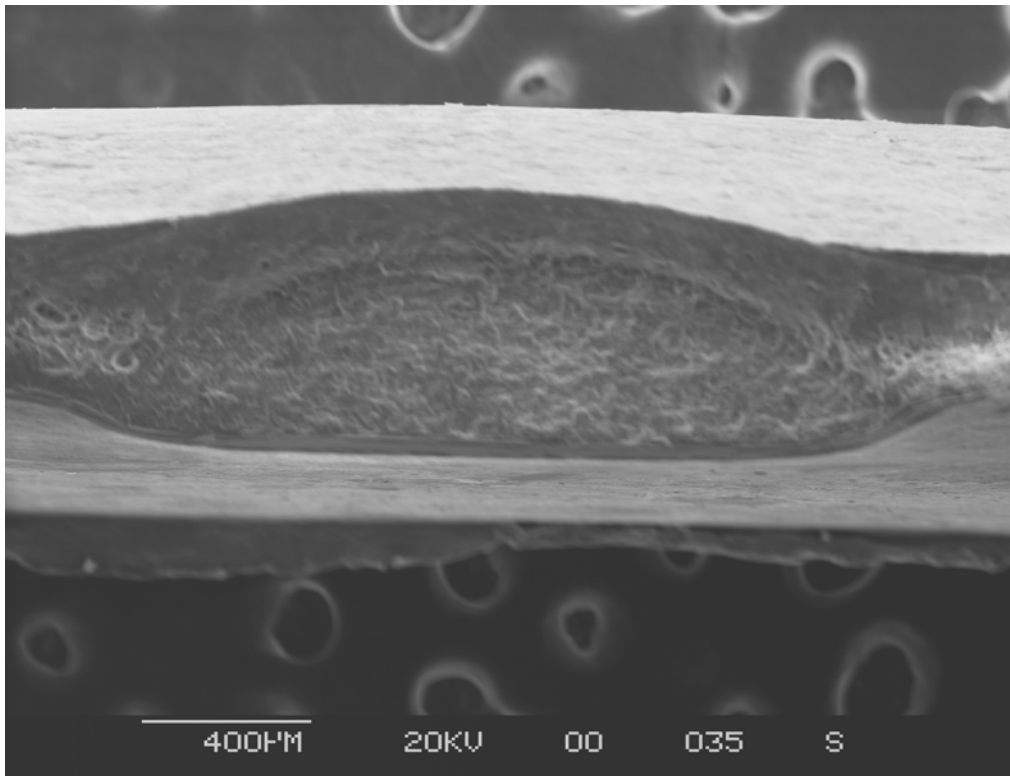
**Figure B-19. Edge Crack on Fracture Surface of Specimen 5636.**

No corrosion was found at the origin of this crack.

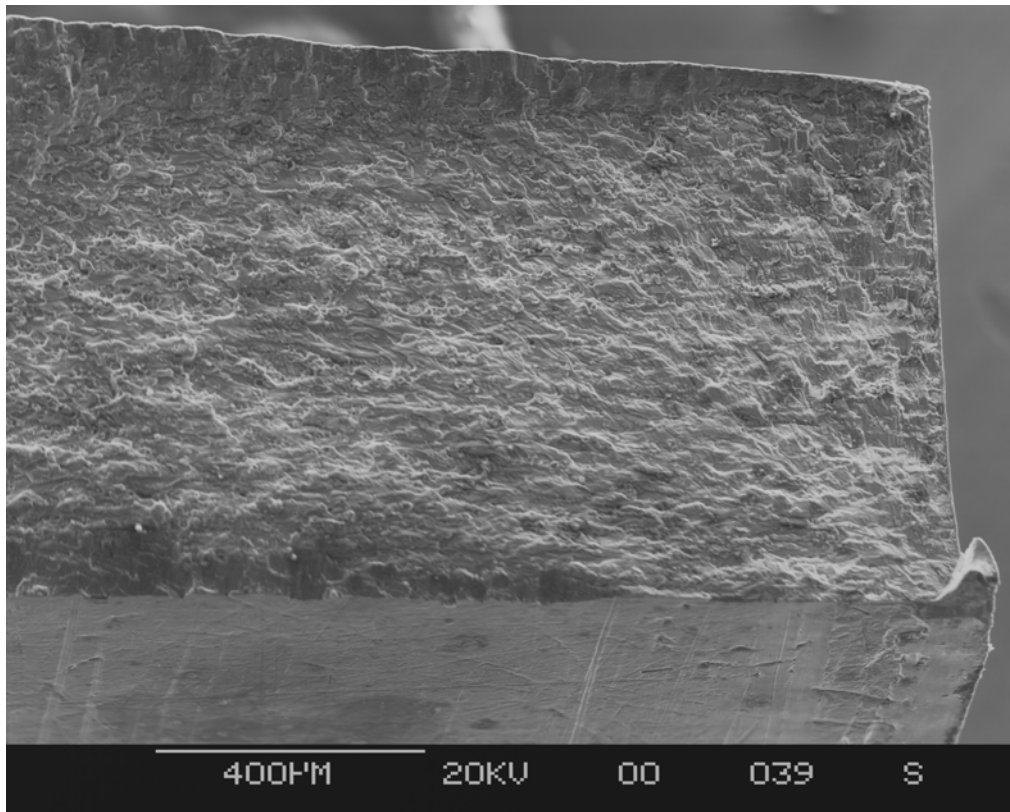
**Figure B-25. Fatigue Crack on Fracture Surface of Specimen 5829.**

Origin is at corner in lower right of photograph.

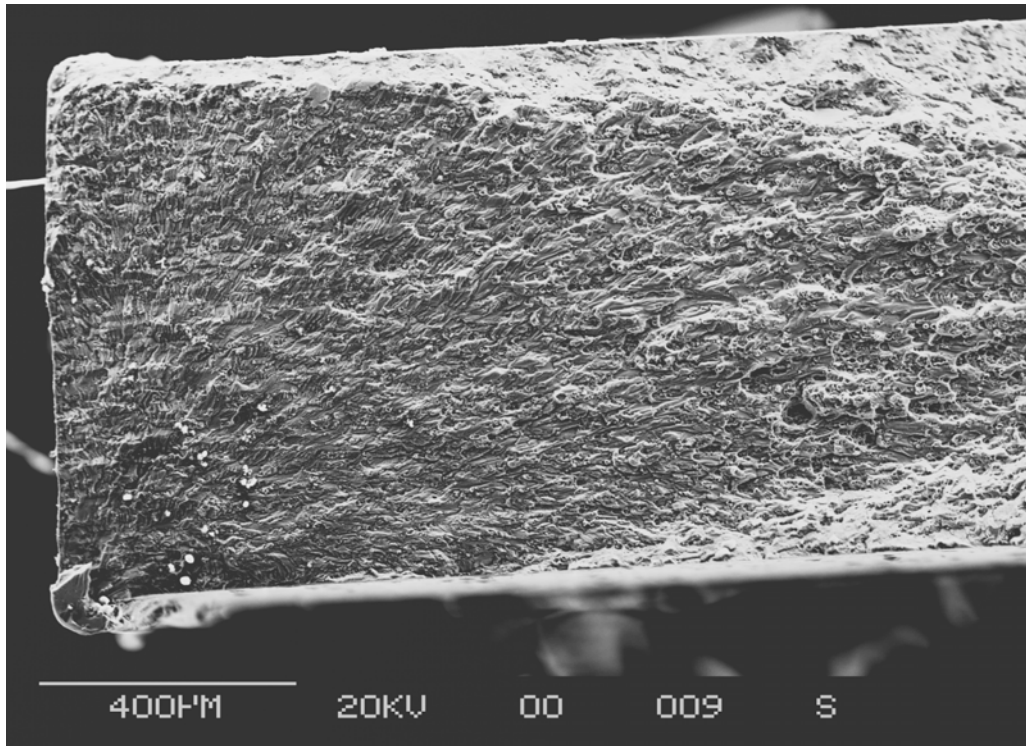
**Figure B-31. Fatigue Crack on Fracture Surface of Specimen 5869.**

Origin is at corner in lower left of photograph.

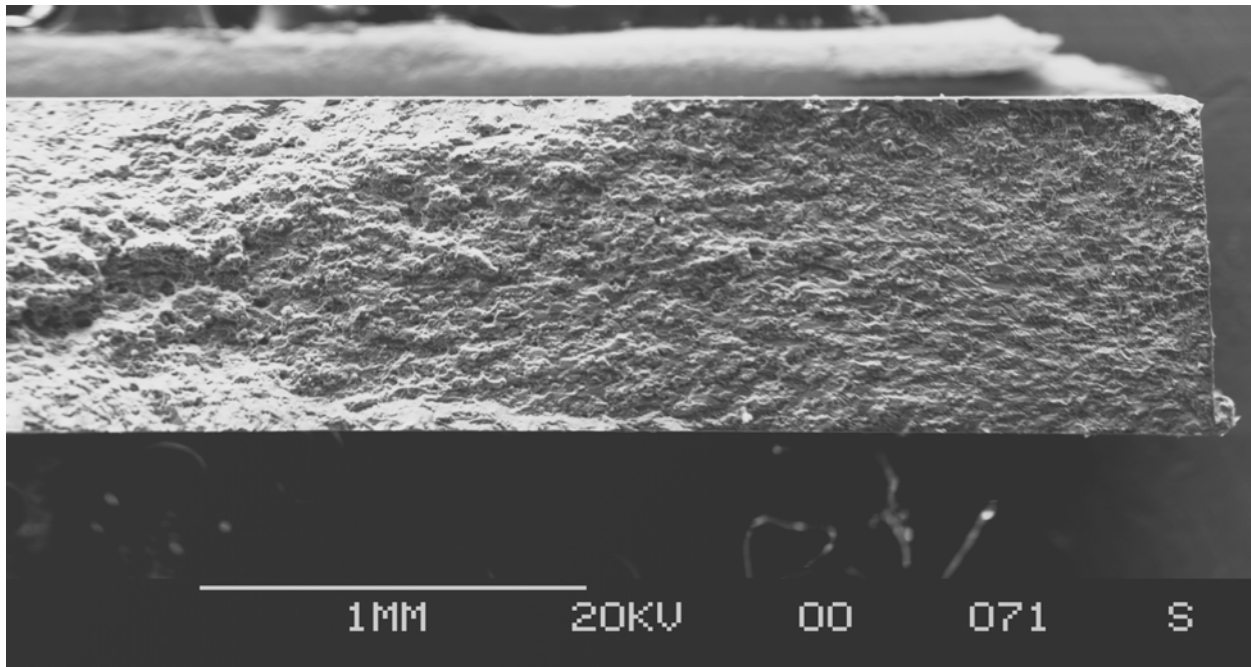
**Figure B-32. Fatigue Crack on Fracture Surface of Specimen 5871.**

Origin is at corner in lower right of photograph.

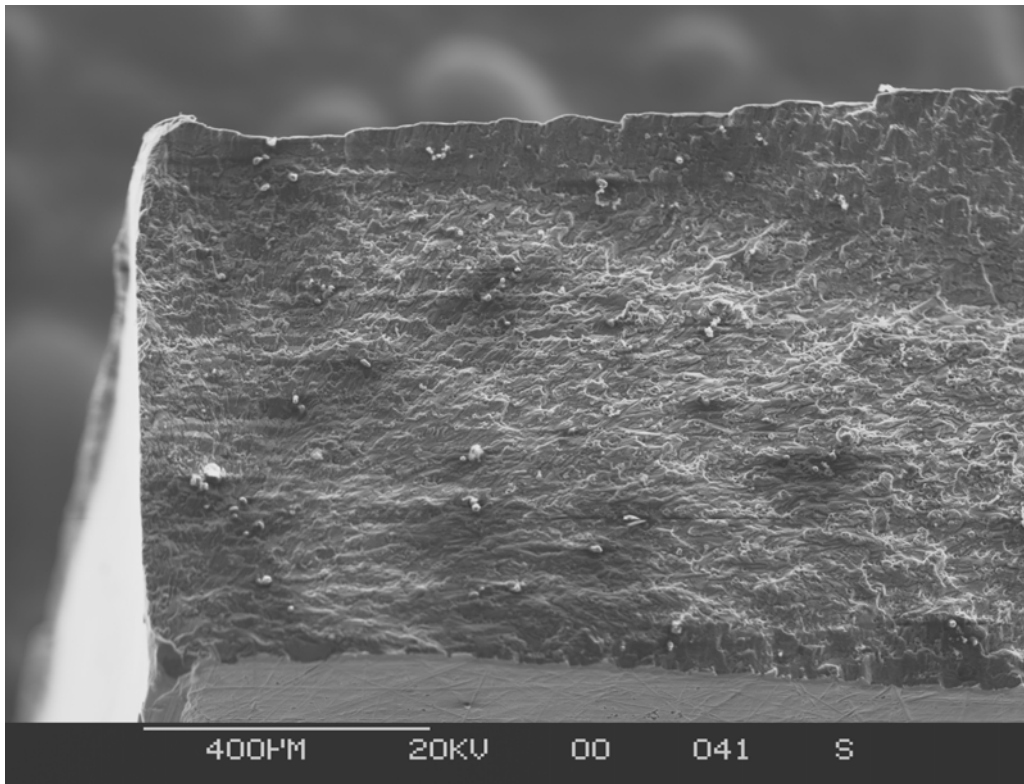
**Figure B-33. Fatigue Crack on Fracture Surface of Specimen 5872.**

Origin is at corner in lower left of photograph.

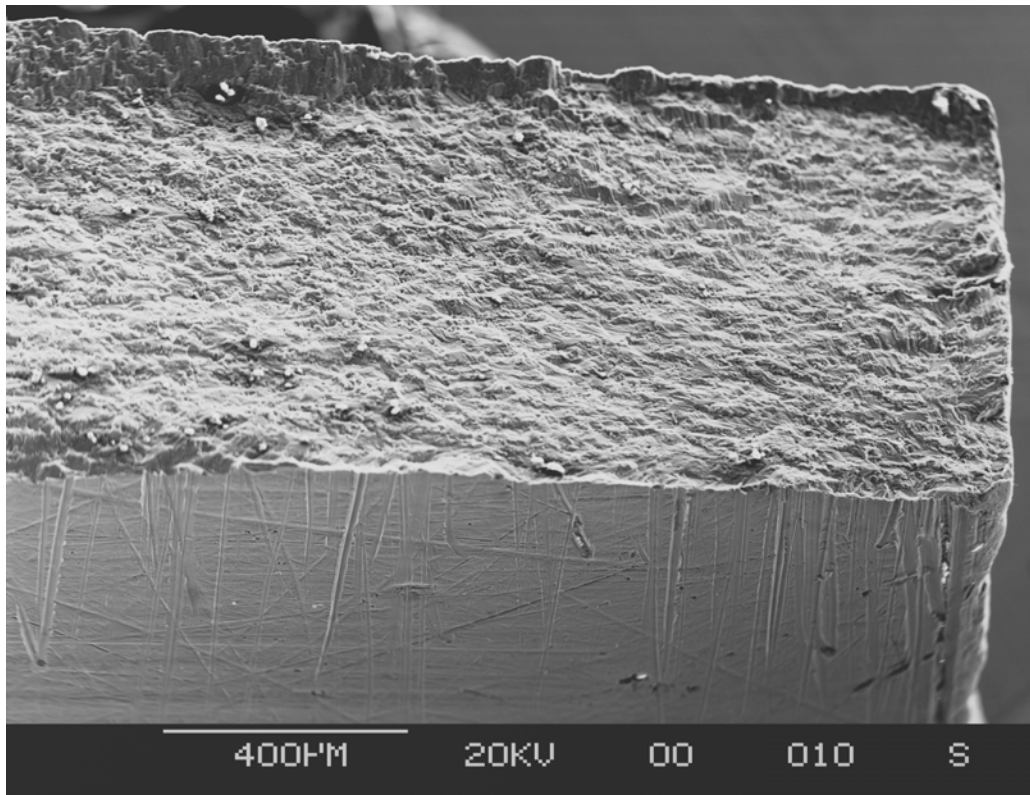
**Figure B-57. Fatigue Crack on Fracture Surface of Specimen 5896.**

Origin is at lower corner at right in the photograph.
